# Monitoring magnetic poles of hydro-generator using vibration data: Case Study and Results

## Introduction

## 1.2 Cerrón Grande Power Plant

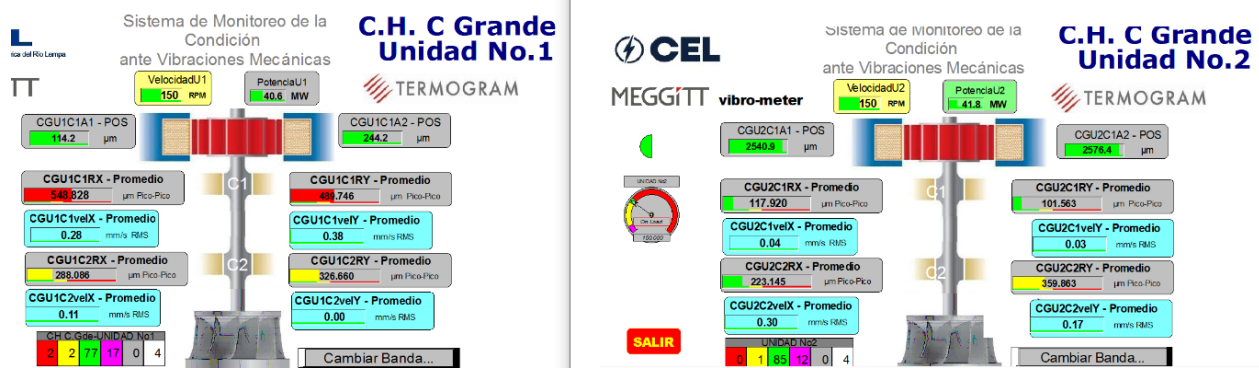
Fig. 4. Mimics of Unit1 and Unit 2, as shown on the local display in control room. The relative vibrations at generator bearing are concerning on unit 1 while reasonable on unit 2. Alerts on the turbine bearing are a consequence, or related to hydraulic phenomena. Light blue value-boxes represent vibration velocity, measured by low-frequency accelerometers.

The levels are in alarm (red colour) and well beyond the limits defined in the standard ISO 7919-5 [2] for relative vibrations:

Limits are, for 150 RPM: A/B: 155 ; B/C: 250 ; and C/D: 510  $\mu\text{m\_Pk-Pk}$ .

The unit should be stopped, according to this standard, if not according to ISO 10816-5 [1] for the absolute vibrations.

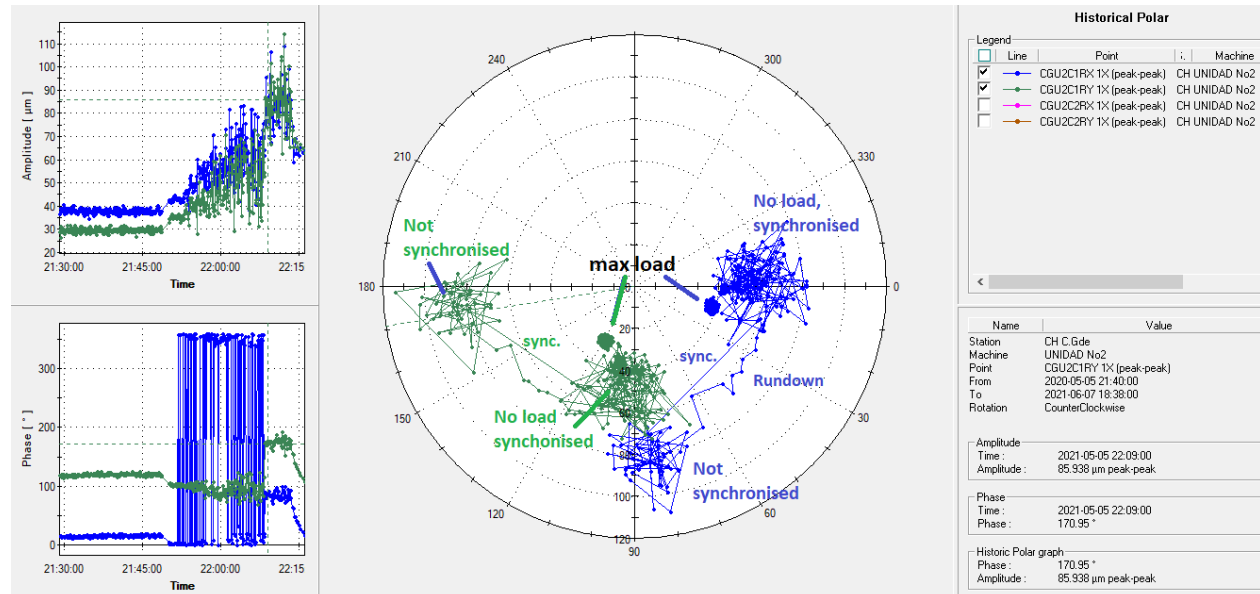
**Fig. 5. Polar plot of X and Y probes in unit 2 generator bearing, showing successively: max load, unloaded, unsynchronised and the rundown. As the X and Y probes are 90° apart, the vectors also show the same 90° offset in phase between X and Y in the diagram.**

For Unit 2 in Fig. 5, at full load, the vectors are represented by small and compact bowls. Then the vectors go apart in more unstable zones (larger bowls), nearby, due to more stochastic instabilities. Then the unsynchronisation causes the vector to shift rapidly to another zone on the polar plot. Eventually the vectors go back gradually to their synchronisation zones. For Unit 2 the synchronisation shift represents approximately 120 microns\_pk-pk in length. But this shift consists more in a phase shift, so that vibration amplitudes remain below 100 microns\_pk-pk on average in all cases. Note that the vector changes with synchronisation and with rundown are in the same direction. This summary on unit 2 shows that the same phenomenon may build up also, like in unit 1. The amplitude of this vector change is acceptable according to the standard ISO20816-5 [3].

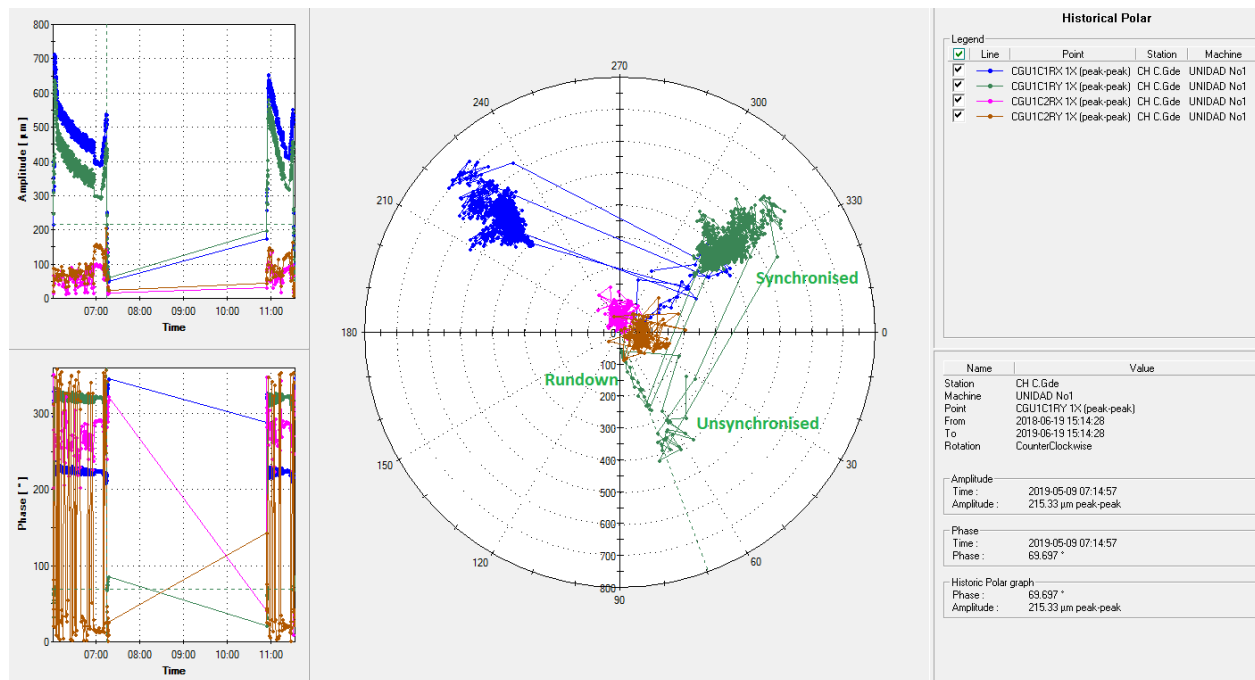
**Fig. 6.** Polar plot of X and Y probes in unit 1 generator bearing, showing successively: max load, unloaded, unsynchronised and the rundown. The vibration at the turbine bearing is represented also on this plot.

For Unit 1, the change in the vectors is also 90° apart between X and Y at the synchronisation event, and also mostly consists of a phase shift for each direction. However, the amplitude of the vectors changes is 800 microns\_pk-pk before the refurbishment.

This amplitude change is fast and clearly due to the synchronisation alone, so is related to the rotating magnetic field in the generator and not related to the mechanical unbalance, which has another phase evolution on the polar plot. We notice that on unit 2, the vector changes with synchronisation and with rundown are no more in phase, but more than 60° apart.

The mechanical unbalance is identified without synchronisation, so it is read (Fig. 6, “unsynchronised”) at 350 microns on both directions X and Y. This is high enough, but is not the main signature. The mechanical unbalance has quite a different phase direction on the plot, than the phase direction of the synchronisation event.

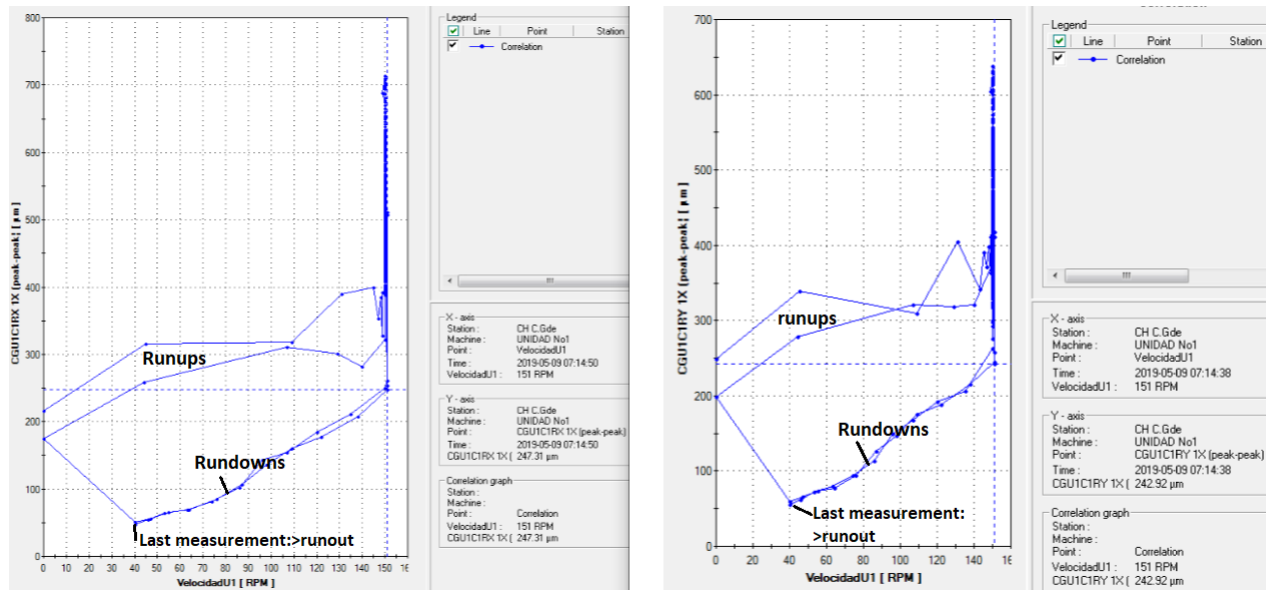
Fig. 7: on unit 1, rundown, the Bodé plot (amplitude), shows that the runout on the X and Y pickups, should be lower than 80 microns.

At low speeds, the measurements (“slowroll”) are not more than 60 microns, so the runout shall not be a concern for the interpretation of amplitudes as high as 800 microns.

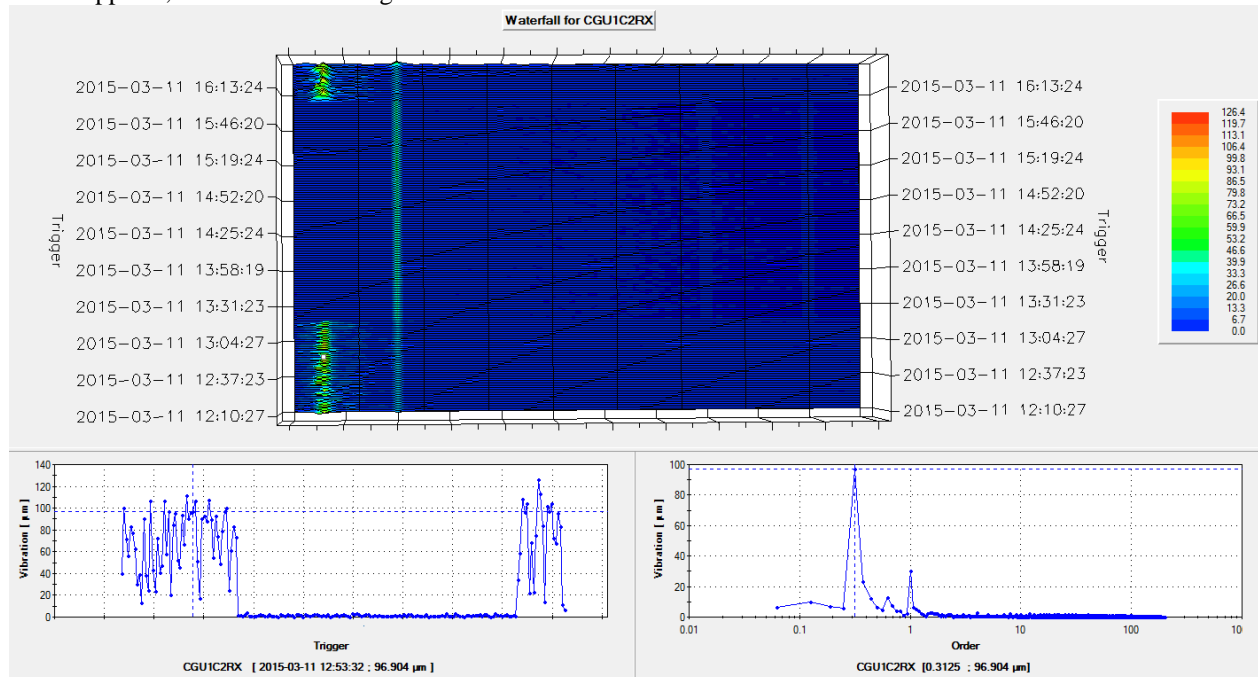
Fig. 8: Spectrogram showing the vortex signature at 0.3X, when load is decreased below 60% of max load: before 19h20 and after 22h10 approx.. The (1X) decreases slightly when this happens.

The hydraulic vortex amplitude reaches 100 microns in this example. It concerns 0.3X, and cannot be responsible for the huge increase on the (1X).

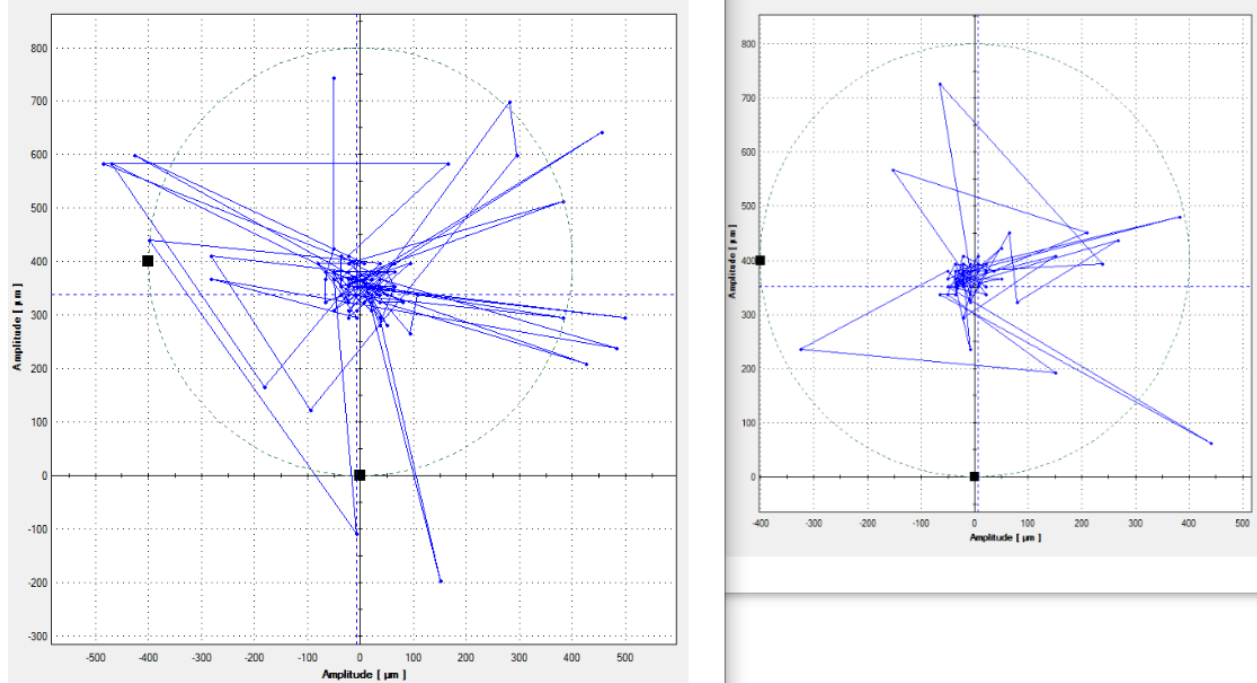
**Fig. 9 :** Shaft Centerlines of unit 1 (left) and unit 2 (right) across the synchronisation event in the upper generator bearing. The circles diameters would represent the clearance in the bearings, Spikes can be explained by other events. There is no dispersion of points in 2 groups like in next figure.

Although spikes are present due to other events (starts, stops, braking steps, load increases and drops), no shift can be clearly seen, related to the synchronisation.

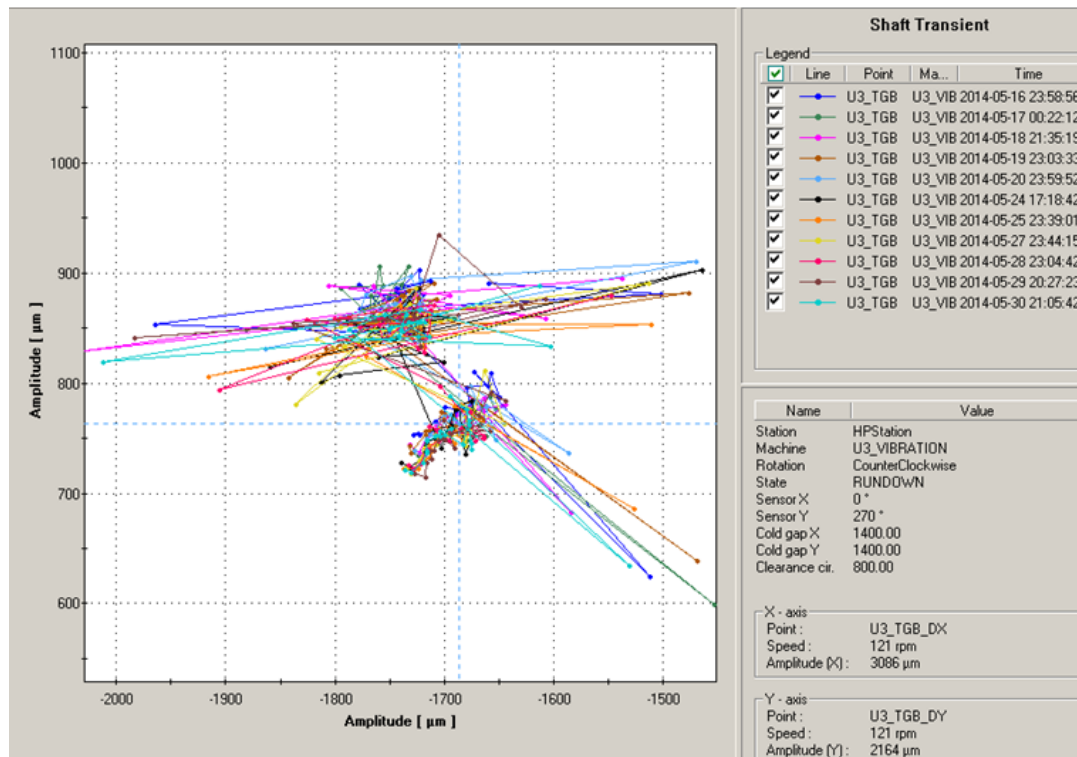
**Fig. 10:** Shaft Centerline plot on another similar hydropower unit where eccentricity is strong, Across several synchronisation & de-synchronisation events, the location of the shaft center shifts quickly resulting in 2 groups of points. This is a sign of a stator wear.

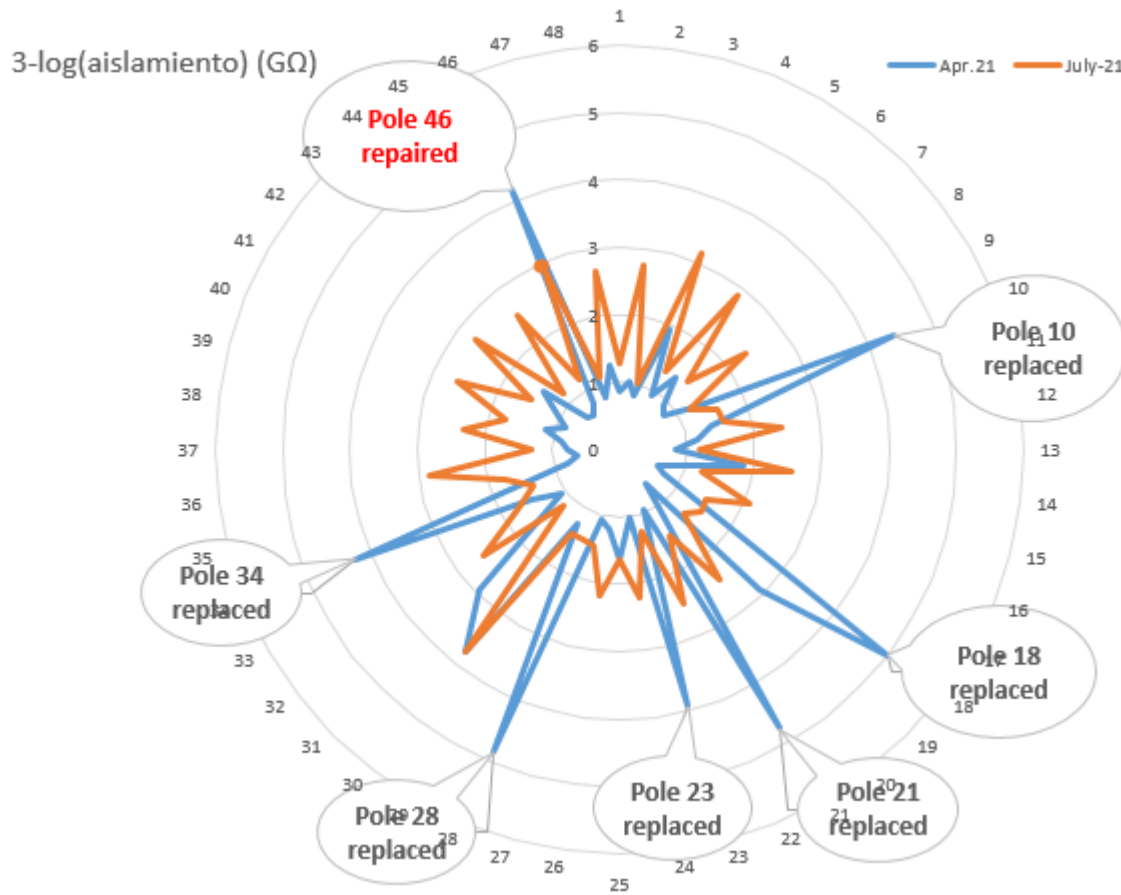
**Fig. 11** : Diagram of poles conductance to ground (inverse of the pole insulation) in log scale. The faulty poles (according to the standard) are spikes in the diagram, before the refurbishment (April, in blue). After refurbishment (July, in orange), the values are all within normative values ( $> 100 \text{ M}\Omega$ ). Environment variables, in particular humidity, may explain lower values for the good poles, after the change.

In the polar representation, we notice that all failing poles: from 10 to 34, are on one half side of the rotor: amongst 24 poles over the 48 totally. Only one pole was in the other side, out of this angular sector, and it was only repaired, for having a higher value of resistance than other 6.

According to the values recorded in the insulation resistance measurements of the poles, 6 poles were replaced and N°46 was repaired. After this was done, they were mounted on the rotor and a new measurement of insulation resistance and voltage drop in the poles were carried out, achieving the nominal resistance values presented in Table 1.

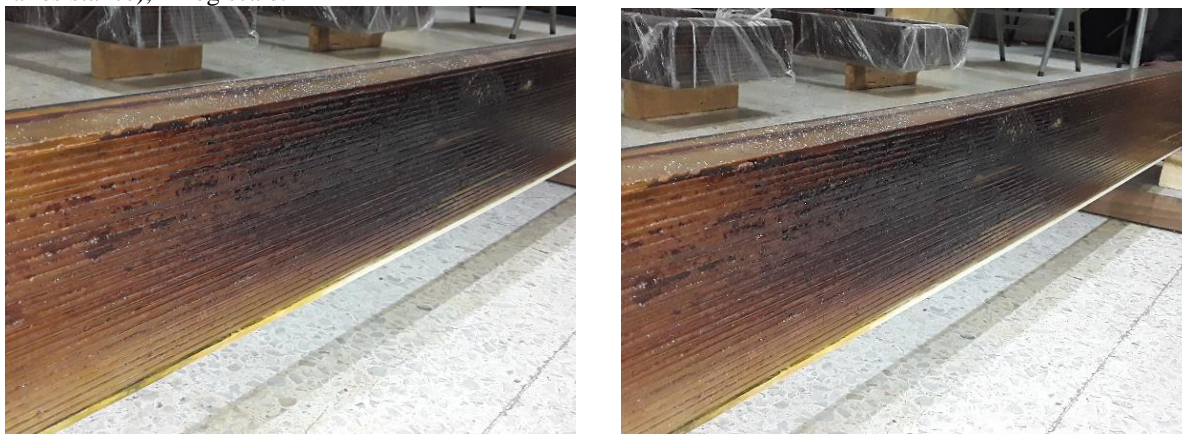
After cleaning, all the failing poles were found burnt in their middle part (around the mid-height of each pole concerned). It is supposed that dust and carbon powder degraded the insulation varnish and eventually short some of insulation plates, as shown on *Fig. 12*. Once the insulation becomes low, spreading currents would cause overheating, thus this aspect of burnt windings.

Although the magnetic field has not been measured, it is verified that the poles failing to pass the insulation test ( $R > 100 \text{ M}\Omega$ ) also appear to be “burnt”, then may have shorted turn(s). The poles have each 14 turns, and then each shorted turn would then reduce the magnetic force by  $\sim 7\%$  (provided that the magnetic field does not saturate the stator bars as mentioned in [3]). While this occurs on 6 poles on one side of the rotor, we can understand that the resulting magnetic force is uneven, and strong enough to generate a measurable unbalance.

**Fig. 12:** Field coil of one of the poles to be rehabilitated, the damage due to overheating is observed, which causes a short circuit in the coils and the subsequent low resistance in the pole.
