CASE STUDY

Replacement
of an unreliable
Machinery
Protection System
to address spurious
trips

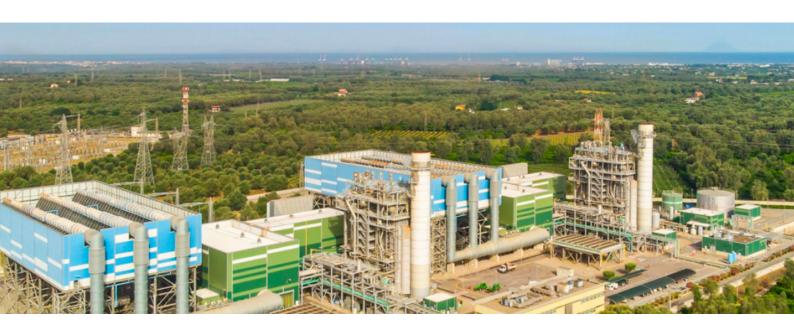
Figure 1: The plants at Rizziconi (shown here) and Sparanise are essentially twins and utilize two 1:1 combined cycle configuration consisting of a 260MW Ansaldo V94.3 gas turbine, a Heat Recover Steam Generator (HRSG), and a 120MW steam turbine. The cooling towers are within the blue structures, the turbines within the green structures, and the HRSGs are the tall structures adjacent to each exhaust stack.

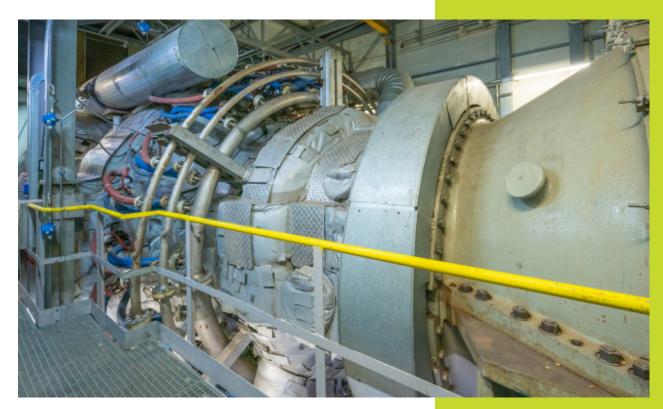
Figure 2: Twin Ansaldo V94.3 gas turbines are at the heart of each combined cycle plant, protected by vibro-meter transducers and VM600 monitoring systems.

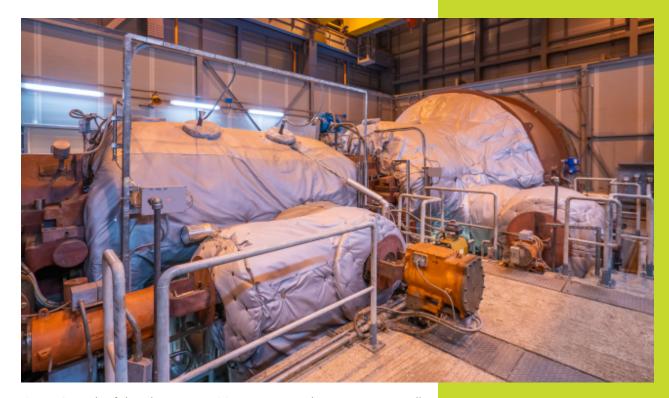
Figure 3: Each of the plants' two 120MW steam turbines were originally fitted with a regional Italian competitor's products that emerged as a source of constant problems with spurious trips – and the ensuing costs therefrom.

The TSI systems have been operational now for more than a year without any spurious trips.
Several modifications were made to the prior arrangement which had the signal conditioners for the proximity probes mounted on the machine, rather than several meters away in a junction box as is customary.

Although the machine-mounted signal conditioners had been suspected as the cause of the spurious trips, the operator had never been able to conclusively isolate this. Nevertheless, the project team placed the signal conditioners off the machine in junction boxes where they could be more easily accessed and serviced, while also providing a vibration-free environment that would not contribute to loose wiring connections and corresponding intermittent problems. Also, because vibrometer transducer systems provide an option for a current-modulated signal output instead of voltagemodulated, a signal that is less
